# 2205 鋼材の品質検査結果

1. 2205 鋼材の品質検査結果

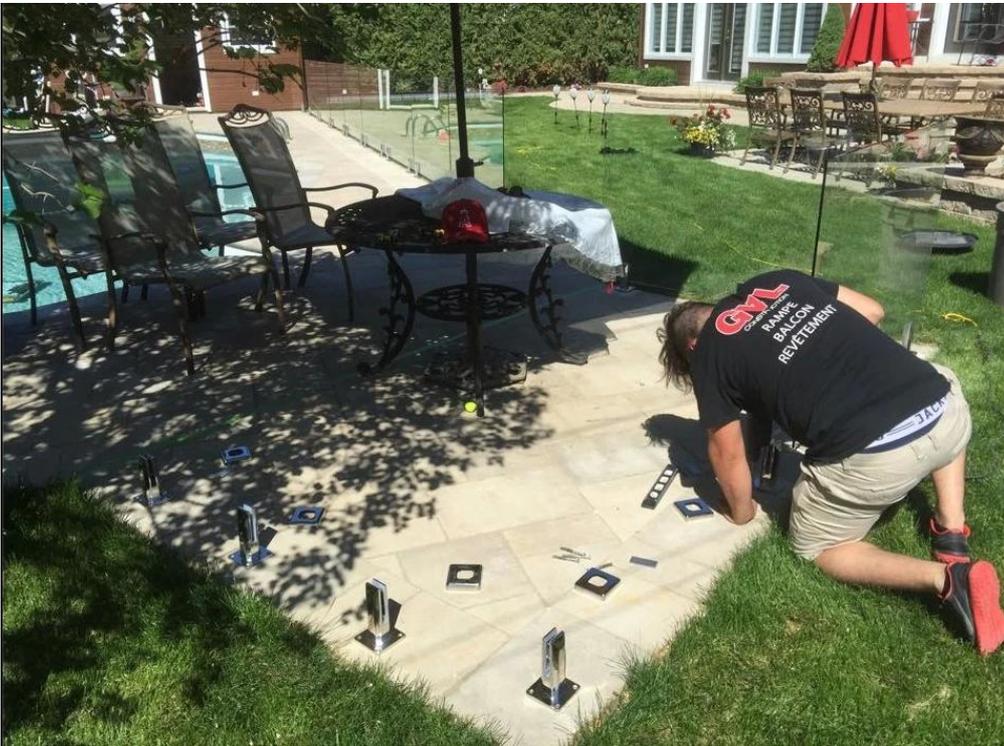
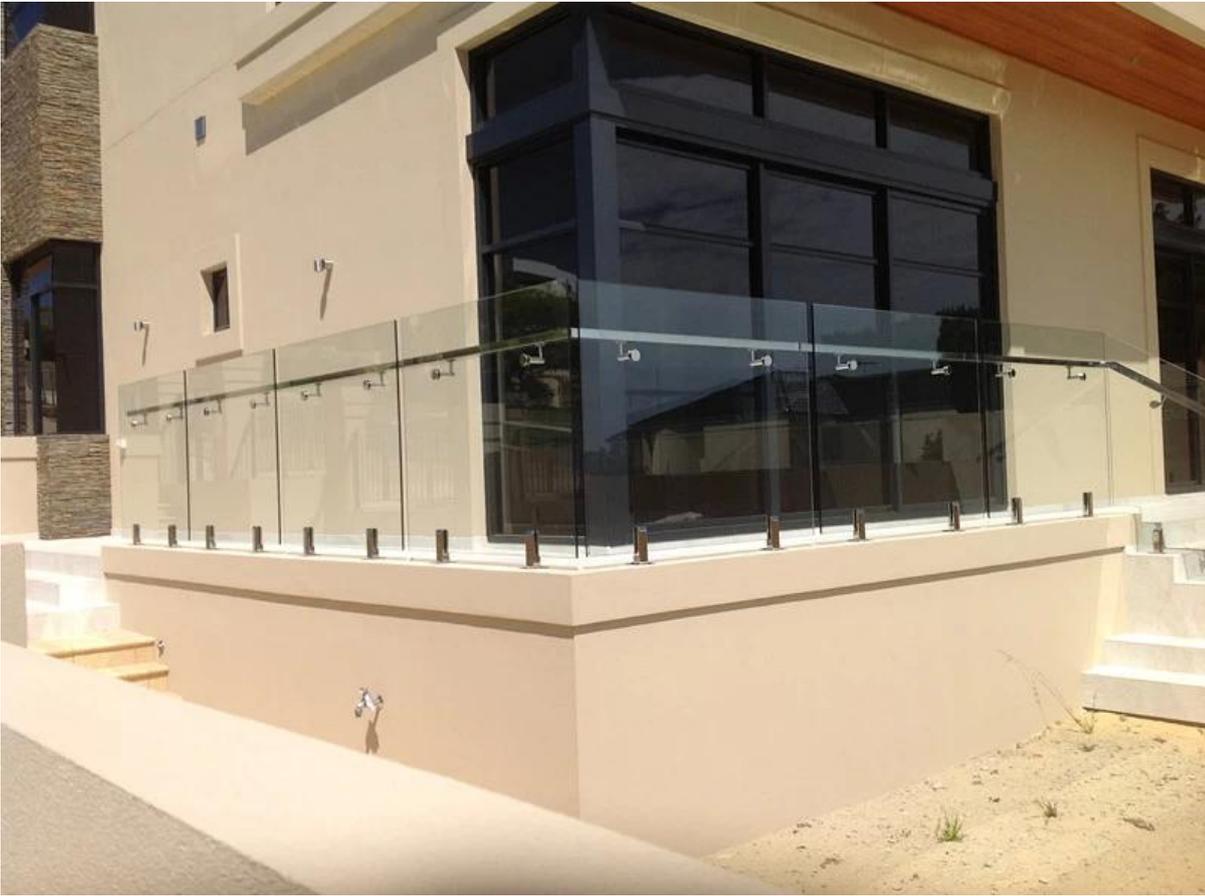
4. 池面にアンカーを埋め込み、デッキを固定する
